# Request for No Further Remedial Action Planned

**Site:** West Dock Fuel Transfer Facility, also known as Two Party Agreement (TPA) Site 9p and National Oceanic and Atmospheric Administration (NOAA) Site 51

Request for NFRAP West Dock Fuel Transfer Facility, TPA Site 9p/Site 51 St. Paul Island, Alaska

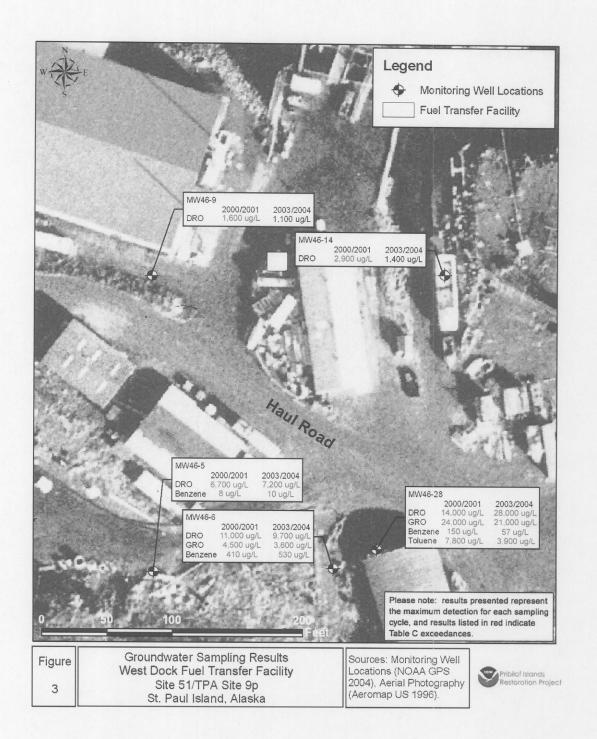
NOAA contractors conducted quarterly groundwater monitoring from September 2000 to September 2001 and from October 2003 to July 2004 in the vicinity of the West Dock Fuel Transfer Facility. During 2000-2001 sampling events, DRO were detected above their Alaska

Department of Environmental Conservation (ADEC) Table C cleanup level of 1,500 μg/l in wells MW46-9 and MW46-14, with maximum detected concentrations of 1,600 μg/l and 2,900 μg/l, respectively (IT Alaska Inc. 2002; Figure 3). During the first three quarters of 2003-2004 sampling, no Table C cleanup level exceedances were detected in wells MW46-9 or MW46-14. High concentrations of DRO and gasoline-range organic compounds (GRO), as well as benzene and toluene, have been detected in wells located up gradient (Mitretek Systems 2002) from the West Dock Fuel Transfer Facility (*e.g.*, 28,000 μg/l DRO and 21,000 μg/l GRO in MW46-28; Figure 3). [Note that NOAA's contractor for the 2001 sampling analyzed for residual-range organic compounds (RRO) by adapting soil analytical method AK103. The adapted method was never approved by ADEC, and no ADEC approved method exists. Thus, although the contractor reported detecting RRO above its ADEC Table C cleanup level in MW46-14, ADEC has indicated it does not consider this data to be valid, and the results are not included herein.]

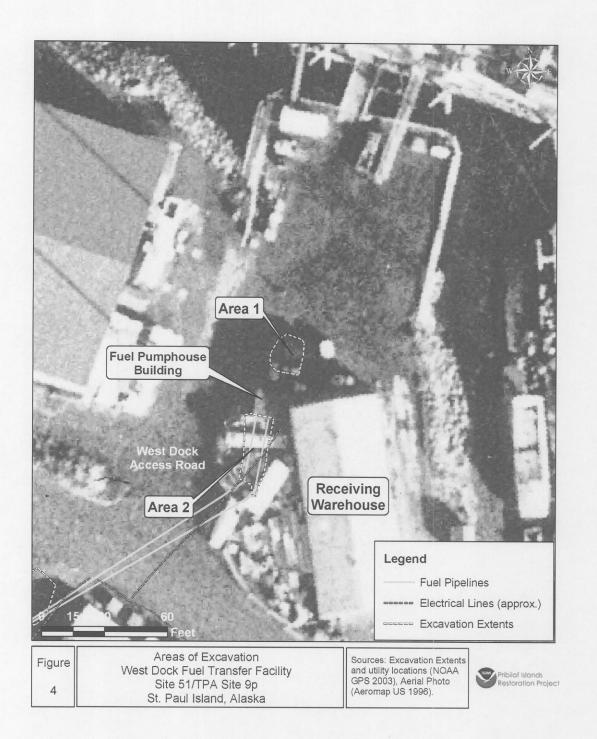
On June 27, 2003, personnel initiated excavation activities at the West Dock Fuel Transfer Facility. Two areas of contamination were excavated during the corrective action (Figure 4): Area 1 (approximately 17 feet long and 15 feet wide) is located north of the pump house; and Area 2 (approximately 35 feet long and 10 feet wide) is located south of the pump house and generally trends from north to south.

Area 1 was selected to investigate a hot spot identified during a sampling event conducted by CESI in 1999 (CESI 2001). The excavation was advanced vertically to a maximum depth of 4 feet bgs, where refusal was encountered, and laterally until no signs of contamination were identified based on TLC screening sample analyses or visual and olfactory observations.

Area 2 was selected to allow removal of the former diesel fuel and gasoline pipelines from this area. As personnel uncovered the former pipelines, the lines were cut, drained, and staged for disposal. The excavation was not advanced beyond a maximum depth of 4 feet bgs because of refusal and the presence of a live electric line crossing the area diagonally beneath the pipelines. The excavation could not be expanded laterally in any direction as a result of the presence of the pump house to the north, a live electrical line to the east and south, and the access road to the west (Figure 4).

Each excavation was backfilled after TLC screening sample analyses indicated contaminant concentrations below ADEC Method Two cleanup levels and fixed laboratory confirmation samples had been collected. If remaining contamination was suspected but further excavation was prevented by the presence of obstructions such as structures, rock, boulders, and utility lines, backfill was also placed after fixed laboratory confirmation samples had been collected. Backfill operations involved transporting clean fill material from the portion of the Telegraph Hill quarry owned by Tanadgusix Corporation (TDX) to the site (Tetra Tech 2004b), dumping the material into the excavation, and compacting the fill material with the excavator bucket or by trackwalking the excavator over the area. Each area of excavation was restored to its original grade. Backfilling and site restoration activities were completed on July 7, 2003.

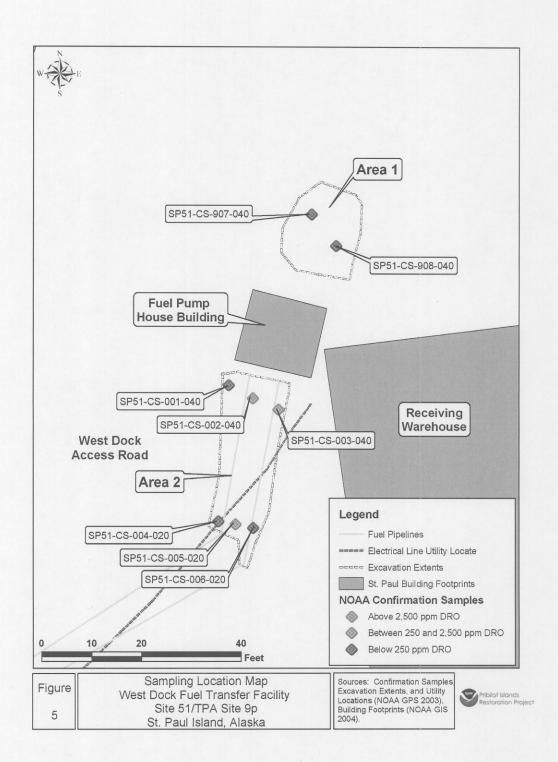
Two confirmation samples were collected from Area 1 and six from Area 2 for laboratory analyses including benzene, toluene, ethylbenzene, and total xylenes (BTEX), DRO, GRO, RRO, select polynuclear aromatic hydrocarbons (PAHs), and lead (Table 1, Figure 5). Confirmation samples collected from the bottom of Area 1 indicated all contaminant concentrations were below their ADEC Method Two cleanup levels. In Area 2, confirmation samples collected from the bottom indicated DRO concentrations that varied from 38 mg/kg to 2,600 mg/kg; three of the six samples collected from this area exceeded the ADEC Method Two cleanup level of 250 mg/kg, and one of the six samples exceeded the alternative cleanup level of 2,500 mg/kg. The sample exceeding the alternative cleanup level for DRO (SP51-CS-002-040) was collected from the bottom of the excavation, which could not be further excavated due to the reasons discussed above. Benzene concentrations in confirmation samples collected from the bottom of Area 2 varied from not detected to 0.15 mg/kg; five of the eight samples collected from this area exceeded the ADEC Method Two cleanup level of 0.02 mg/kg, but none of the samples

exceeded the alternative cleanup level of 0.5 mg/kg. Concentrations of all other contaminants in confirmation samples collected from Area 2 were below the ADEC Method Two cleanup levels.
